**Flood Control Project Maintenance  
Levee Inspections**

## Maintenance Issue Types Only, Levee Inspection Report By Mile - Spring 2015

### Marysville Levee Commission

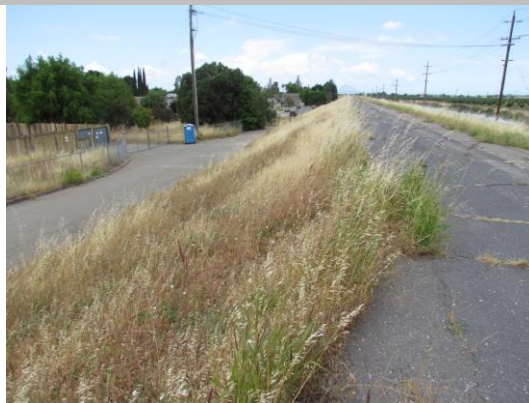
Photo 1 of 1 : SP\_2015\_NA0004\_104\_10\_20150520\_00002.jpg

LM Start	0.02	Rating **	M	Issue No.	10
LM End	3.15	Issue Type +	Ma	Location *	LS
Category	Earthen Levee			GPS Latitude/Longitude	
				Start	End
Item	Vegetation			39.149856 °	39.164086 °
				-121.600998 °	-121.560836 °
DWR ID	DWR_NA0004_01_s _ 2015_10				
Action/Comments					
Control annual grass and weeds on the levee slopes and easements.

View of the vegetation on the landside of the levee facing downstream.

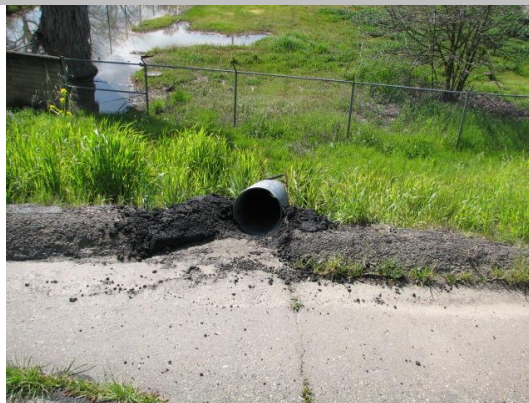
Photo 1 of 1 : SP\_2015\_NA0004\_104\_1\_20150401\_00001.jpg

LM Start	3.23	Rating **	A/W	Issue No.	1
LM End	3.23	Issue Type +	Ma	Location *	LS
Category	Earthen Levee			GPS Latitude/Longitude	
				Start	End
Item	Slope Stability			39.163590 °	39.163590 °
				-121.559495 °	-121.559495 °
DWR ID	DWR_NA0004_01_s _ 2012_1				
Action/Comments					
Repair slope instability. Inspector Comments: This drain pipe has been added to the site on the Corps PI.

This site is on the Corps PI.

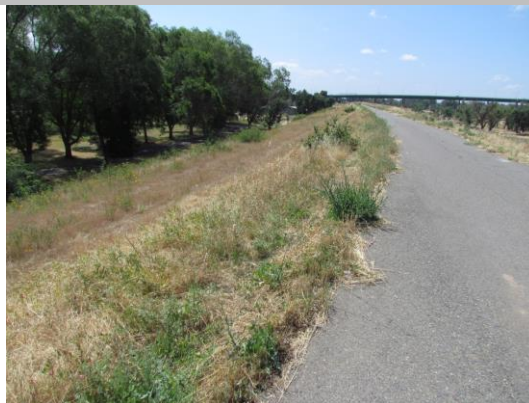
Photo 1 of 1 : SP\_2015\_NA0004\_105\_5\_20150520\_00002.jpg

LM Start	0.01	Rating **	A/W	Issue No.	5
LM End	1.23	Issue Type +	Ma	Location *	LS
Category	Earthen Levee			GPS Latitude/Longitude	
				Start	End
Item	Vegetation			39.149439 °	39.134764 °
				-121.601109 °	-121.594121 °
DWR ID	DWR_NA0004_02_s _ 2015_5				
Action/Comments					
Control annual grass and weeds on the levee slopes and easements.

View of the vegetation on the landside of the levee facing downstream.

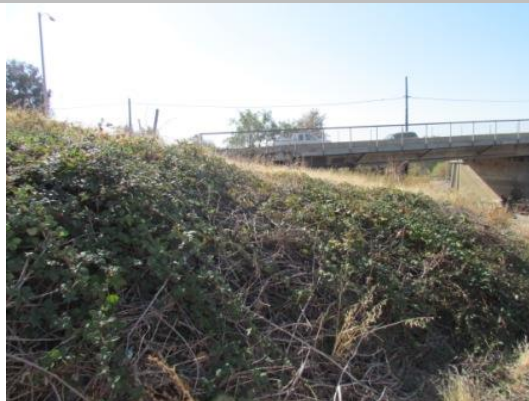
Photo 1 of 1 : SP\_2015\_NA0004\_105\_9\_20150401\_00001.jpg

LM Start	0.70	Rating **	M	Issue No.	9
LM End	0.70	Issue Type +	Ma	Location *	WS
Category	Earthen Levee			GPS Latitude/Longitude	
				Start	End
Item	Vegetation			39.139752 °	39.139752 °
				-121.600637 °	-121.600637 °
DWR ID	DWR_NA0004_02_f_2013_9				
Action/Comments					
Remove the wild growth other than native grasses from the levee slopes.					
Inspector Comments: Blackberries on waterward levee slope.

This photo was taken from the access road going under the 5th street bridge of blackberries growing on the waterward levee slope. Fall 2013.

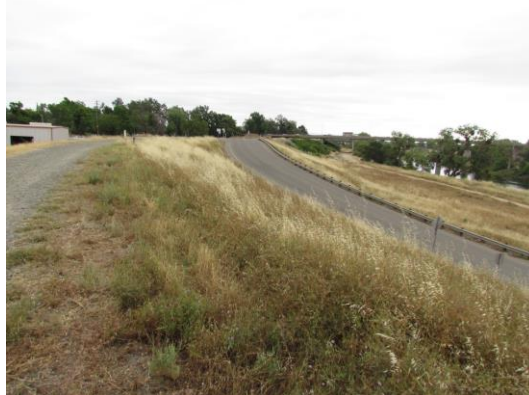
Photo 1 of 1 : SP\_2015\_NA0004\_106\_26\_20150520\_00007.jpg

LM Start	0.01	Rating **	M	Issue No.	26
LM End	3.70	Issue Type +	Ma	Location *	WS
Category	Earthen Levee			GPS Latitude/Longitude	
				Start	End
Item	Vegetation			39.134858 °	39.172095 °
				-121.593641 °	-121.552278 °
DWR ID	DWR_NA0004_03_s _ 2015_26				
Action/Comments					
Control annual grass and weeds on the levee slopes and easements.

View of the vegetation on the waterside of the levee facing downstream.
